Case Study: Inter-floor Leakage in High-Rise Residential Buildings in Malaysia (Kajian Kes: Kebocoran Antara Tingkat di Bangunan Kediaman Bertingkat Malaysia)

The subject of this case study is a freehold condominium unit located at Batu 9 Cheras, Selangor with vacant possession in July 2017. The housing scheme is accessible to Cheras-Kajang Highway, Jalan Cheras and Jalan Hulu Langat that leads to KL and Kajang. Some nearby landmarks include Central Brigade PGA Cheras and Central Selangor District Forest Office. The condominium is equipped with facilities such as a swimming pool, badminton hall, playground and 24-hour security. It is part of a three towers complex consisting 596 units with built-up areas ranging from 1,127 to 1,557 square feet.

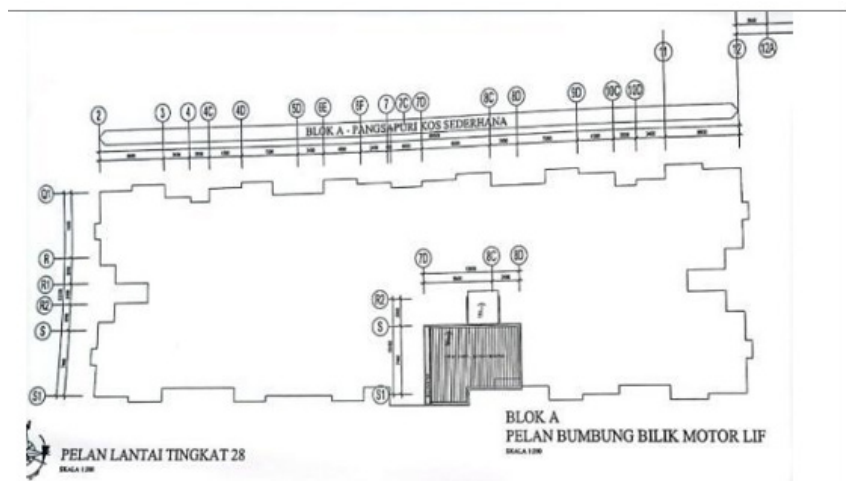
FIGURE 2. Floor plan of the rooftop and motor lift room

since the DLP. Despite attempts to fix the defect, the leak has persisted. Water dripping and yellowish damp stains on the plastered ceiling suggest seepage from the rooftop, suspected a waterproofing failure or external wall cracks from the motor lift room as shown in Figure 2.

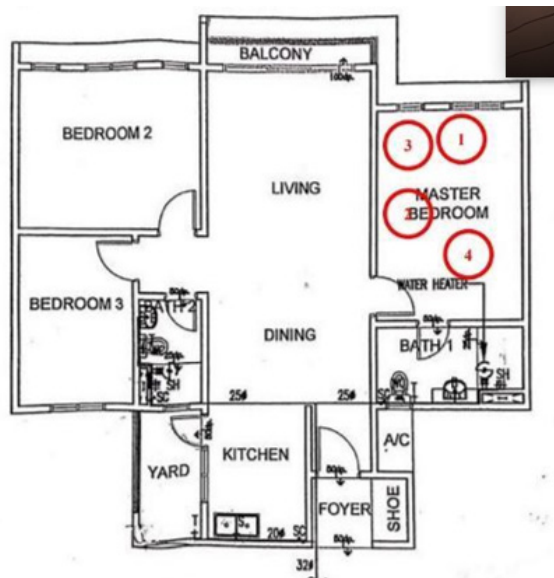
FIGURE 3. Floor plan of the subject unit and dampness test spots / locations

This test consists of three categories, namely, Visual, Destructive and Non-Destructive Tests. The equipment used during the test are humidity detector (humidity metre), infrared thermography camera and drone. Figure 3 is a damp spot discovered under the metal roof.

The origin of the dampness came from cracked external walls and poor waterproofing on the concrete flat roof under the metal roof. The investigation finds the following: -

1. A crack in the parapet wall;
2. A crack in the wall next to the Lift Motor Room; and
3. Improper slope and termination of concrete flat roofs.

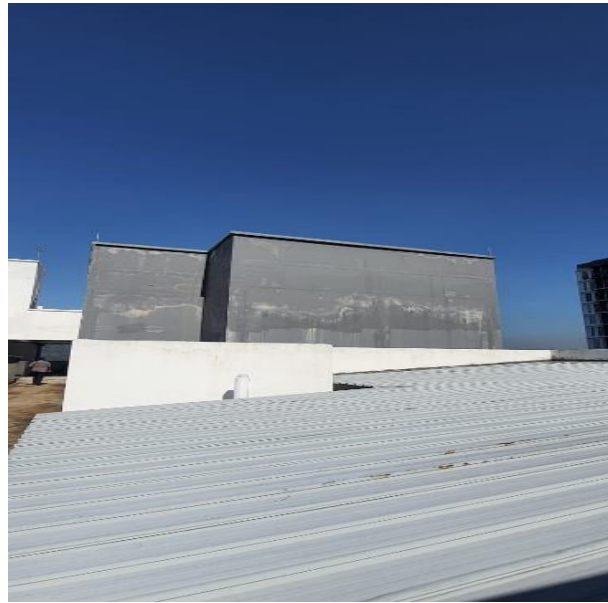
FIGURE 4. Metal roof at the rooftop were dismantle to test dampness at Location 1 and 2

Inspections and tests are carried out on the flat roof of the subject unit by dismantling the metal roof for a thorough inspection as shown in Figure 4. Tests show high levels of moisture in the soffit. Excessive heat on the roof has caused severe cracking of the outer and parapet walls. Inadequate heat control measures and worsening climate change can exacerbate cracking in the future. As a result, rainwater seeps through cracks and pools at the very bottom of concrete flat roofs with poor gradients and terminations.

Spot of test	Moisture meter reading	Diagnose	Causes	Suggestion
Location 1	4.7%	High level of dampness on the soffit	Seepage from external wall cracks/roof	Repair external wall cracks, heat control and re-waterproofing
Location 2	3.6%			
Location 3	3.9%	Cracks and high level of dampness on the external walls	Seepage from external wall cracks and migration of rainwater into to the metal roof	Repair external wall cracks, heat control and re-waterproofing
Location 4	3.9%

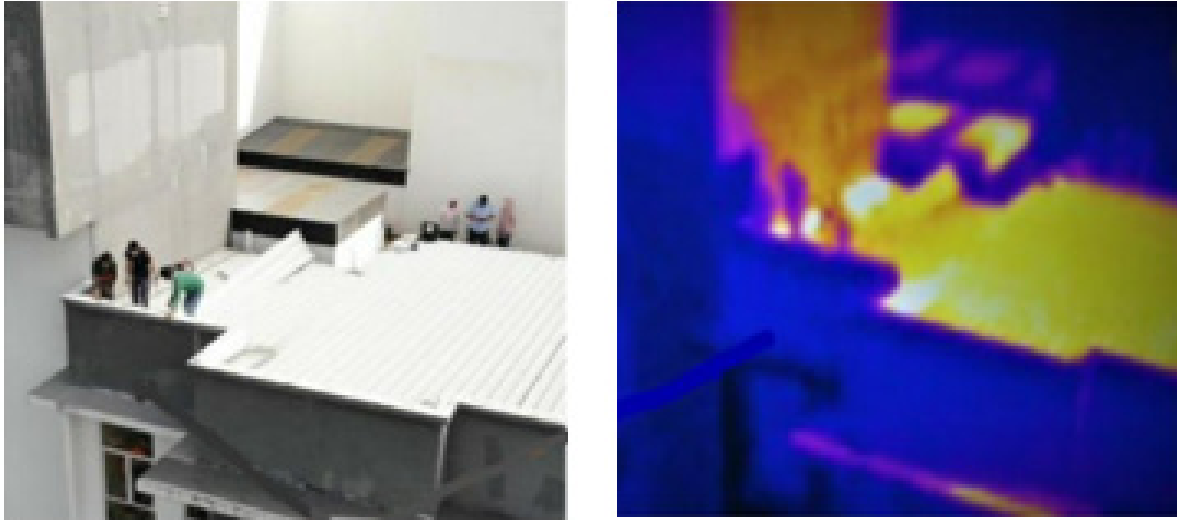
FIGURE 5. Rooftop area and infrared thermographic imaging at Locations 1 and 2

Tests using drones with an infrared thermal camera on flat roof areas in Figure 5 show that the efflorescence (white spots) appear darker in infrared thermographic

The picture shows a damp spot on the rooftop. Infrared cameras indicate moist material; that is, hot areas are shown as red while cold areas are shown as blue on the device's LCD display. The device produces thermal images of materials and provides quick identification of potentially damp areas by showing temperature variations on the surface.

waterproofing of the concrete flat roof under the metal roof. Defects at Locations 1 and 2 illustrate the cracked conditions of the parapet wall and those at Locations 3 and 4 outline pockets of water from the cracked wall in the Motor Lift Room that moved down due to gravity. Water seeps through the cracks and ends up as wet spots 1 and 2 with poor or no waterproofing, which occurs at the lowest point.

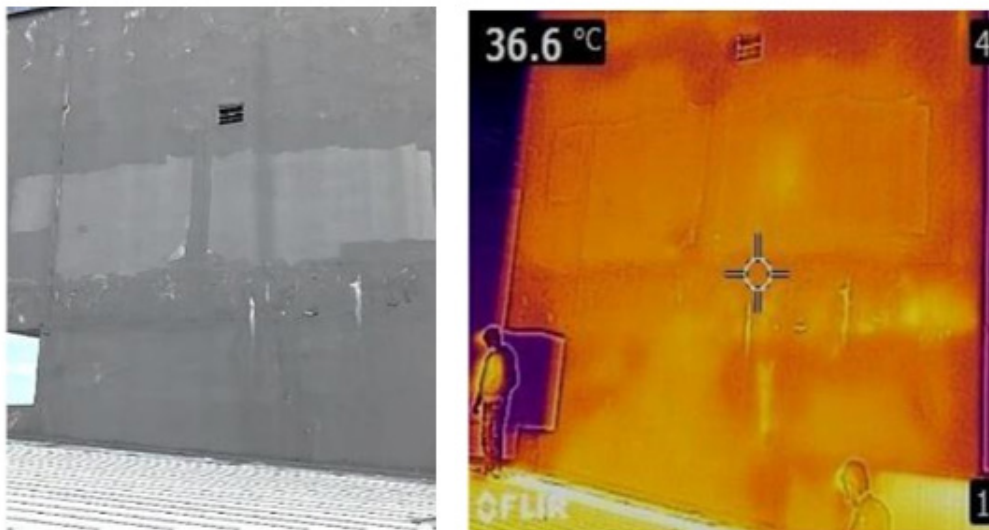
FIGURE 6. Rooftop area and infrared thermographic imaging at Locations 3 and 4

Although these devices do not directly detect humidity or measure moisture, they do indicate warmer and cooler zones. Figure 6 shows water pockets in orange and red patches. The diagnosis is that cracks and high moisture levels on the exterior walls cause seepage from the exterior wall cracks and passage of rainwater to the metal roof.

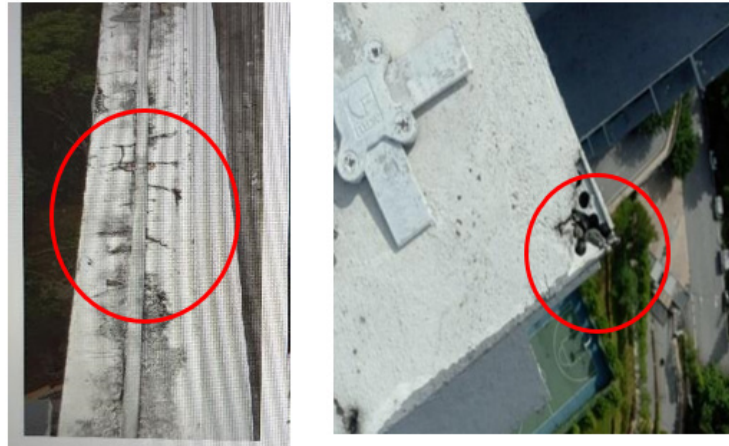
FIGURE 7 Cracks, chipped cement screeds and cavities in the walls

Additionally, cement debris and cavities in the walls closest to the leak area also contribute to water seepage into the unit, as shown Figure 7 below.

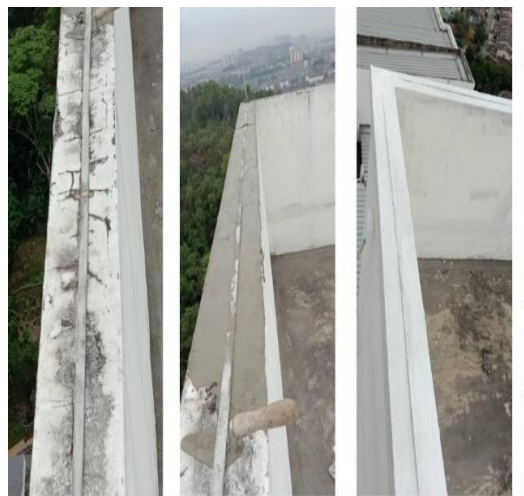
Cracks on flat roofs are severe due to exposure to maximum solar energy and differences in orientation and coefficient of thermal expansion of concrete and infill brick walls. Cracks can be avoided if control connections and thermal control are specified. However, leakage can be reduced by converting existing cracks into extension joints. Figure 8 shows the repair work of a wall adjacent to the lift motor room. Heat can be controlled by using white paint on the walls and installing thermal insulation which may reduce the stress caused by solar energy. Figure 9 shows the wall adjacent to the lift motor room after it is painted to white.

FIGURE 8. Repair work of a wall adjacent to the lift motor room.

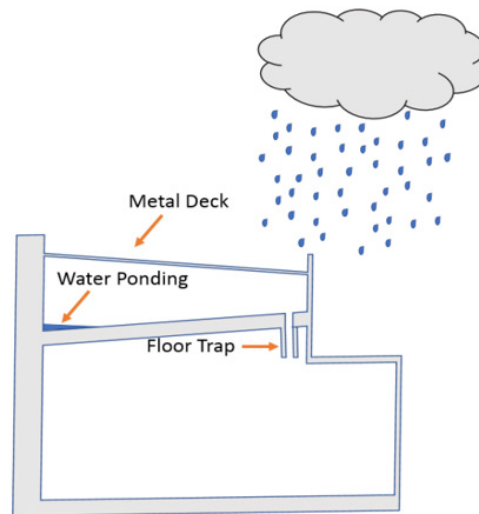
FIGURE 10. Cross section sketch of flat roof

Although the flat roof is protected by a metal roof, its poor slope causes rainwater to seep through the vertical flashing with gaps.

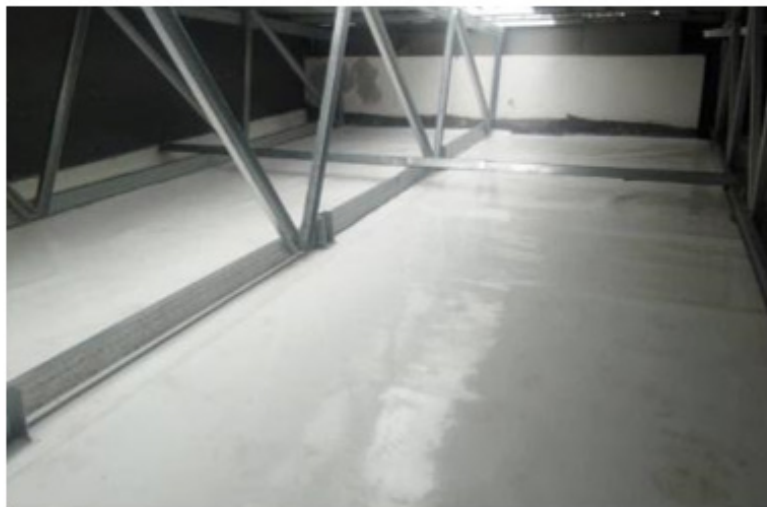
The reading of the moisture metre on the waterproof coating in the trough with the incorrect gradient highlighted above clearly indicates the quality loss of the waterproof coating.

The restoration waterproofing coating with fibre mesh reinforcement must be highly elastic to withstand all types

of pressure and movement on a flat roof. Single-ply membranes were installed under the metal roof, as depicted in Figure 12.

FIGURE 12. Single-ply membranes are installed under the metal roof
