## Internal Characteristics of Loose Solid Source of Debris Flow in Zhouqu (Ciri Dalaman Sumber Pepejal Bebas Aliran Puing di Zhouqu)

### ABSTRACT

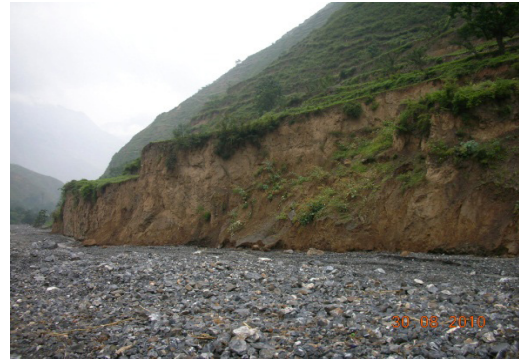
PHOTO 1. A collapse at the study area

According to field investigation, the loose solid source of debris flow in the research area mainly included collapsed accumulation, landslide accumulation, residual slope accumulation and valley accumulation and the collapsed accumulation was the main loose solid source of debris flow in this basin. In addition to debris flow formed by direct accumulating or blocking of valley by collapsed mass and landslide mass, the debris flow on slope formed by the erosion of loose collapse mass and landslide mass on the slope by slope runoff was also one of the main factors causing the debris flow in valley. Therefore, landslide accumulation and collapsed accumulation were sampled as the test objects (Photos 1-2, Figures 1-2). Distribution of debris flow in Nanyu Valley and sampling points are shown in Figures 3.

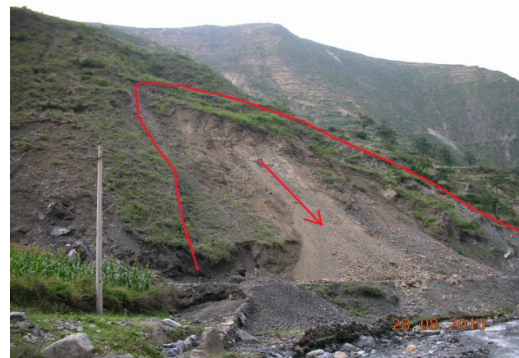
PHOTO 2. A slide at the study area

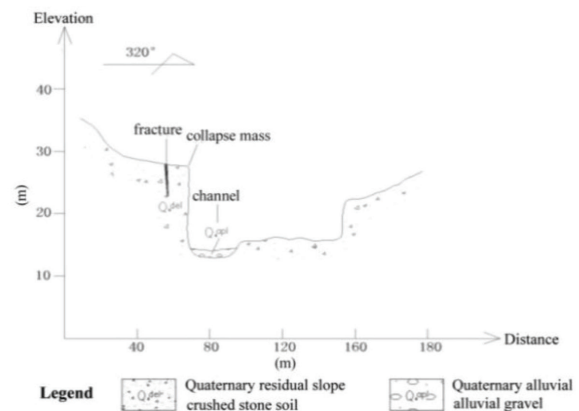
FIGURE 1. Sections of typical collapse

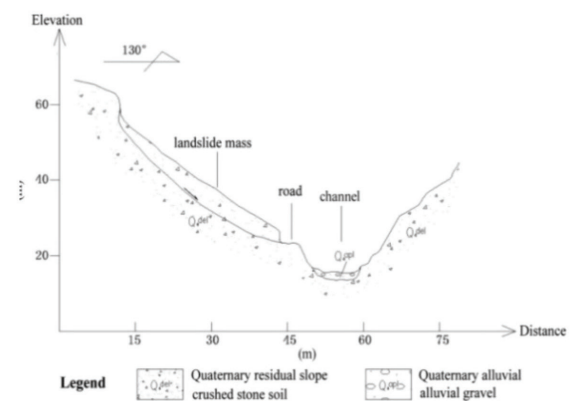
FIGURE 2. Sections of typical landslide

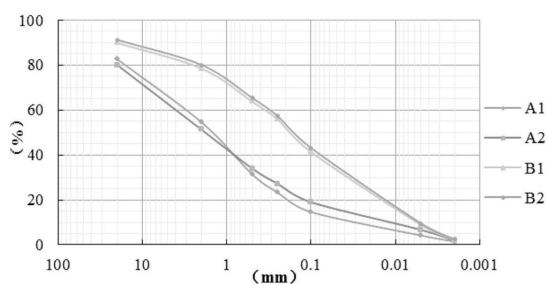
FIGURE 4. Particle size distribution curve of original sample

From particle size distribution curve shown in Figure 4, the high content of gravel and sand and the low contents of clay and silt in landslide/collapsed accumulation bodies provided a good condition for the infiltration of rainfall. The clays and silts accounted for 14.6% and 19% at the slope top (A1) and slope toe (A2) of the landslide accumulation body, respectively, which showed that many clays and silts at the slope top of the landslide accumulation body were scoured away by the runoff under the scouring effect of rainfall, thereby proving that the degree of soil erosion at the slope top was serious when the slope of the accumulation body was steep, exhibiting the characteristics of runoff gully development and considerably different particle sizes. The clays and silts accounted for 41.3% and 43.1% at the slope top (B1) and slope toe (B2) of the collapsed accumulation body, respectively, which showed that few clays and silts at the slope top of the collapsed accumulation body were scoured away by the runoff under the scouring effect of rainfall, thereby proving that: the degree of soil erosion at the slope top was not serious when the slope of the accumulation body was gentle.

The analysis results of particles at the slope top and slope toe of the landslide/collapsed accumulation bodies showed that: the loss of clays and silts was serious when the degree of soil erosion at the slope top was serious, exhibiting the characteristics of high dispersibility; the slope toe accumulated part of clays and silts scoured down from the slope top. Therefore, the contents of clay and silt gradually increased from the slope top to the slope toe.

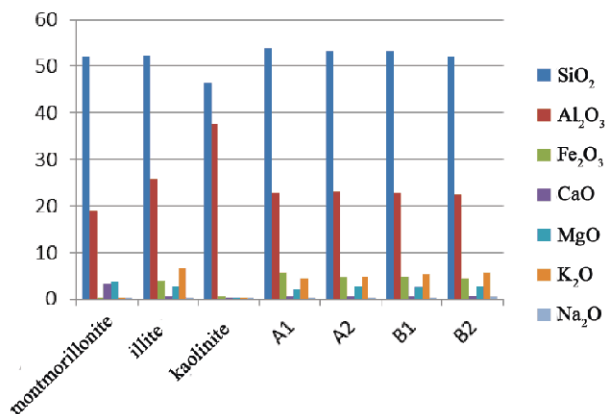
FIGURE 5. Chemical composition of the sample debris flow (quality percentage)

The  $\text{SiO}_2/\text{R}_2\text{O}_3$  ratios of the landslide accumulation body was smaller than that of the collapsed accumulation body, indicating that the soil of the collapsed accumulation body was smaller than that of the landslide accumulation body; the contents of  $\text{K}_2\text{O}$ ,  $\text{Na}_2\text{O}$ ,  $\text{CaO}$  and  $\text{MgO}$  at the slope top were lower than those at the slope toe, indicating that under the influence of long-term weathering and rainfall, the soluble potassium, sodium, calcium, magnesium gradually migrated from the slope top to the slope toe and enriched at the slope toe.

CLA was a chemical alteration index and a physical quantity reflecting the degree of soil erosion under natural weathering. The greater the CLA, the greater the degree of soil erosion under natural weathering and the greater the dispersion of soil. Figure 5 shows that: The weathering degree of the landslide accumulation body was

stronger than that of the collapsed accumulation body; the weathering degree of the slope toe was stronger than that of the slope top, therefore, it was easy to form a large number of loose solid matters at the slope top, thereby providing a rich solid source for the formation of debris flow.
