BUILT AND FORGOTTEN: UNVEILING THE DEFECTS ASSOCIATED WITH THE GHANA COCOA BOARD (COCOBOD) JUBILEE HOUSE IN KUMASI

Abstract

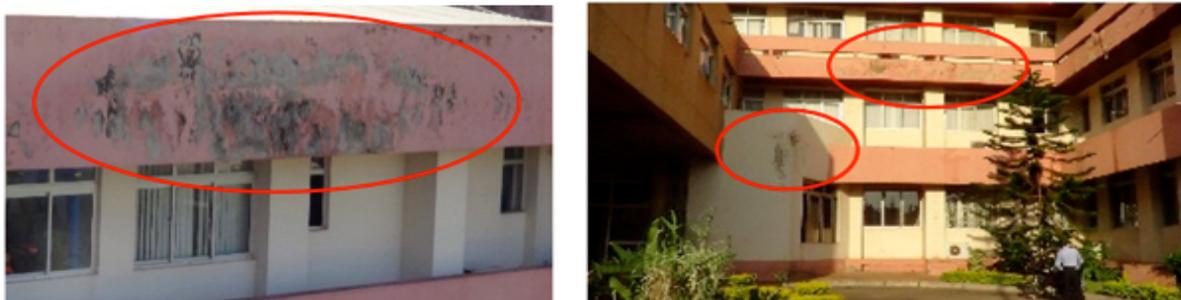
Peeling of paints was identified as one of the key defects associated with the building. A critical examination of the building revealed that the elements, especially external elements of the building were consistently exposed to sunlight, rain, wind, etc. This could be a possible reason why most of the elements were affected by this defect. The defect could also have been caused by moisture penetration through the walls of the building. When water seeps through the substrate due to improper application of water proofing membranes around pipe penetrations, joints and walls in shower and bath areas, this problem can easily occur (Chew and Da Silva, 2003). In Figure 2a, it can be seen that the original colour of the building was a shade of pink, but on direct exposure to the elements of the weather, the walls had been stained and the paints had peeled off.

Figure 2a: Peeling of paint resulting from the direct exposure of the building to sunlight, wind and rain

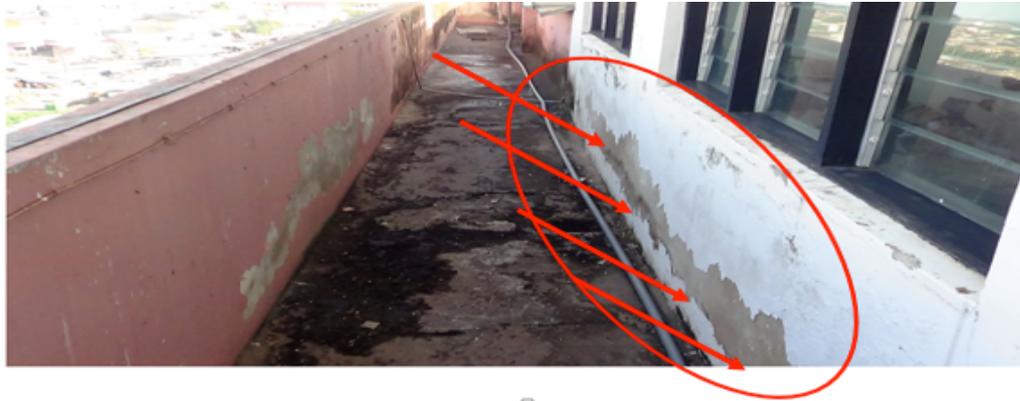
Figure 2b is also a photograph taken from the on-site inspection of the building. It shows that the action of moisture in the wall of the building had peeled off the paint on that part of the building. This peeling of the paint had resulted in the surface discolouration of the wall, revealing the surface rendering. This defect usually occurs on facades, mainly on plastered walls, columns and other areas which are exposed to excessive rain and dampness (Ahmad, 2004). As a result of the constant wind, rain and sunlight received on the exposed parts of the building under investigation, those parts had been severely affected.

Figure 2b: Peeling of paint resulting from the action of moisture in the walls of the building

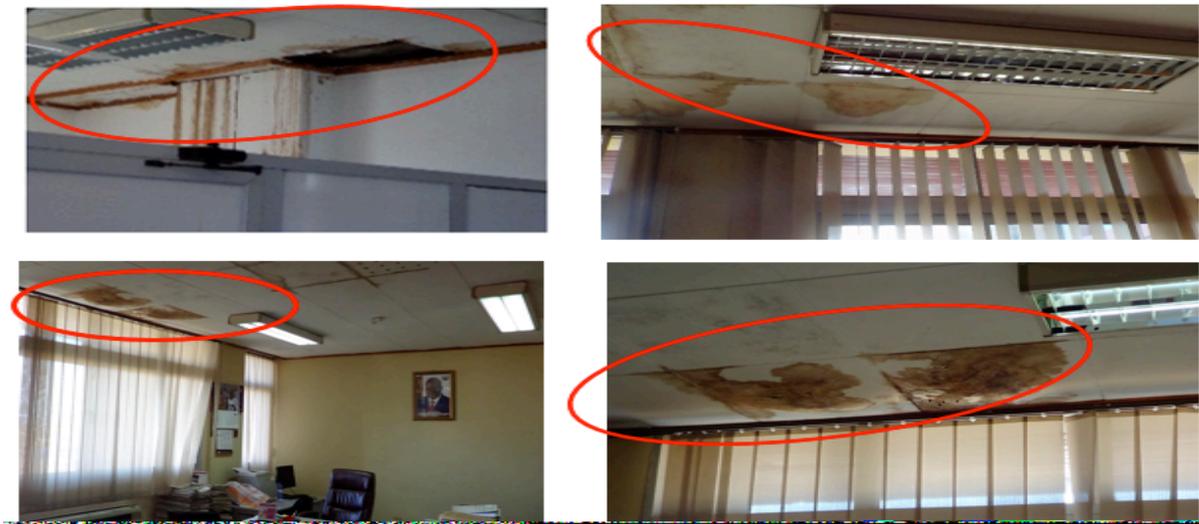
Leakages in ceilings was also identified in the rooms located in five of the floors of the building. According to Chew and De Silva (2003), leakages in ceilings are normally caused by discontinuities of the ceiling or slab, inadequate provision/treatment of movement joints, waterproofing and interfaces. Most of the times the discontinuities in the ceilings are due to pipe penetrations and joints (either expansion or contraction joints or both) (Chew and De Silva, 2003). The on-site inspection of the building revealed that the leakages in the ceilings resulted from a combination of failed flashings, damaged damp proof layers on top of the roof slab, damaged roofing sheets, leaking pipes, among others.

Figure 3a: Signs of ceiling leakages inside the building

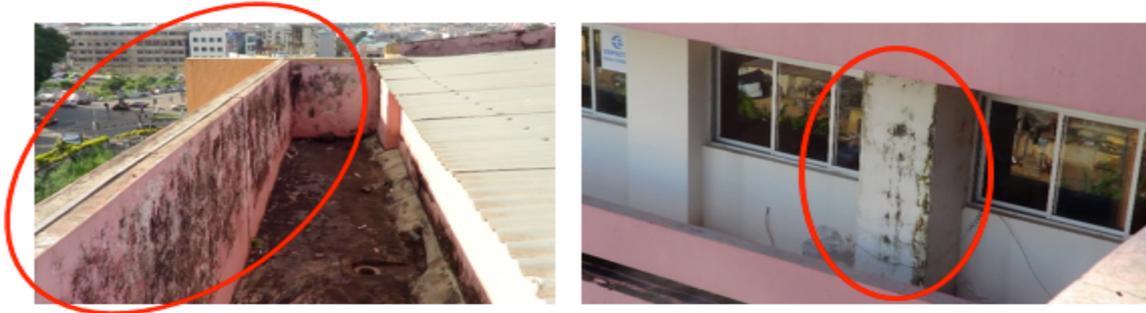
The on-site inspection of the building revealed that the surface discoloration appeared in brownish, blackish and yellowish colours. The problem was very prevalent all around the external and some internal walls of the building. The stains and discolouration of the building were found to be associated with the presence of dampness and other biological attacks. This finding corroborates literature. In a similar study by Suffian (2013), most building facades in Malaysia were identified with stains associated with water run marks, growth of algae, fungus, etc. According to Ahmad (2004), fungal stains or mould occur in buildings when there is moisture in those buildings.

Figure 4 Stains and discolouring of walls

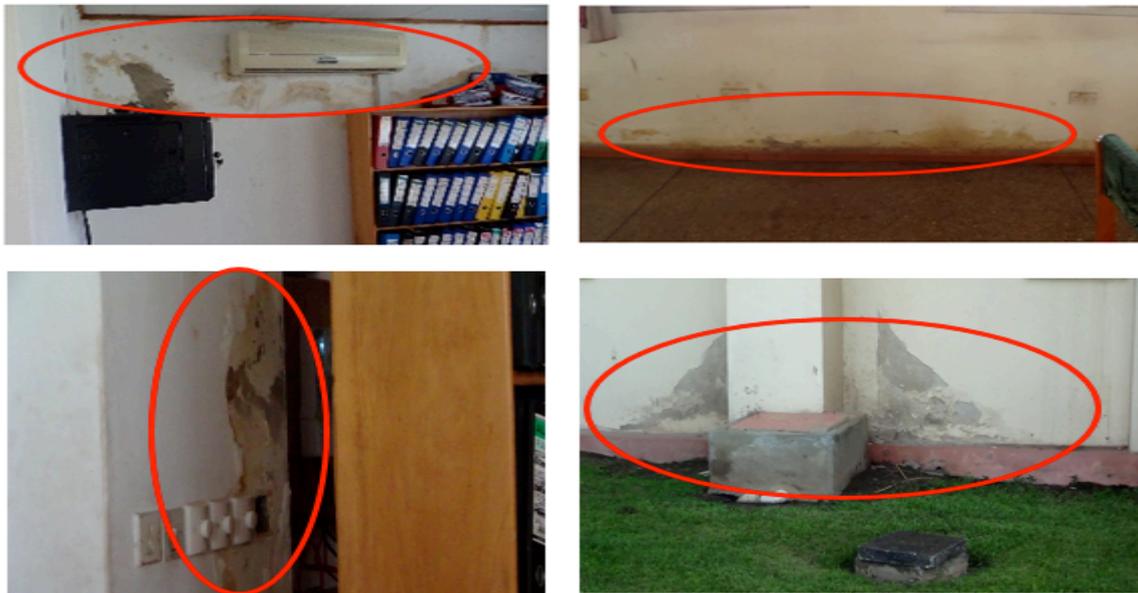
Dampness, the penetration of water through the walls and certain elements of a building was identified as one of the defects severely associated with the building. This problem is very dangerous because it is one of the most damaging defects that can occur, whether a building is old or of recent construction (Hetreed, 2008; Burkinshaw and Parrett, 2004).

Figure 5a: Dampness resulting from water leakages and below ground water sources

A critical examination of the damp areas of the building with the moisture meter revealed that the walls were severely affected. The examination further revealed that the dampness that resulted in the building was as a result of water penetration in the form of leakages (Figure 5a). These leakages occurred on the first to the six floors. The dampness on the external wall of the basement was due to rising damp. This type of dampness was associated with symptoms such as surface efflorescence, horizontal tidemarks, etc.

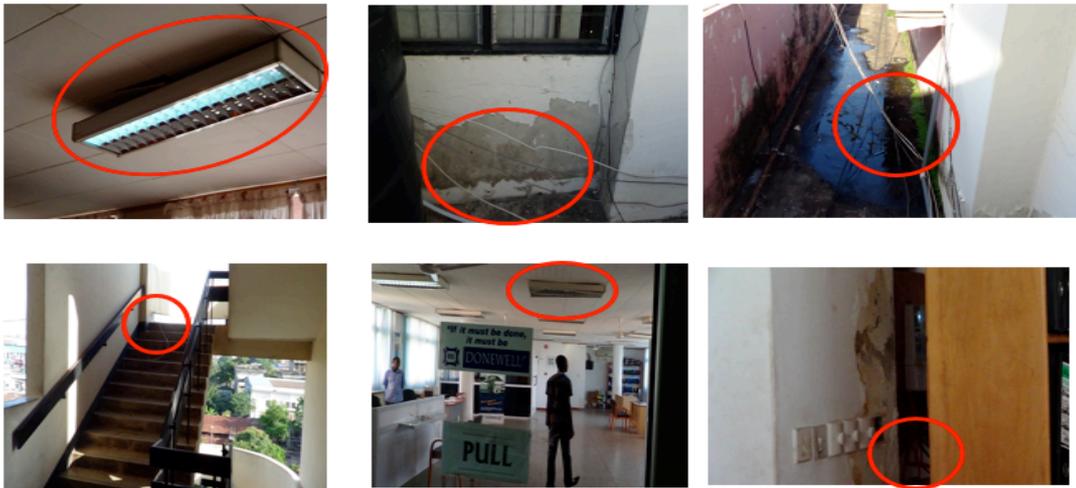
Figure 6: Faulty electrical fittings

The inspection revealed that most of the electrical fittings were faulty. For those which were functioning, they were so close to the damp areas such that occupants or users could be electrocuted.

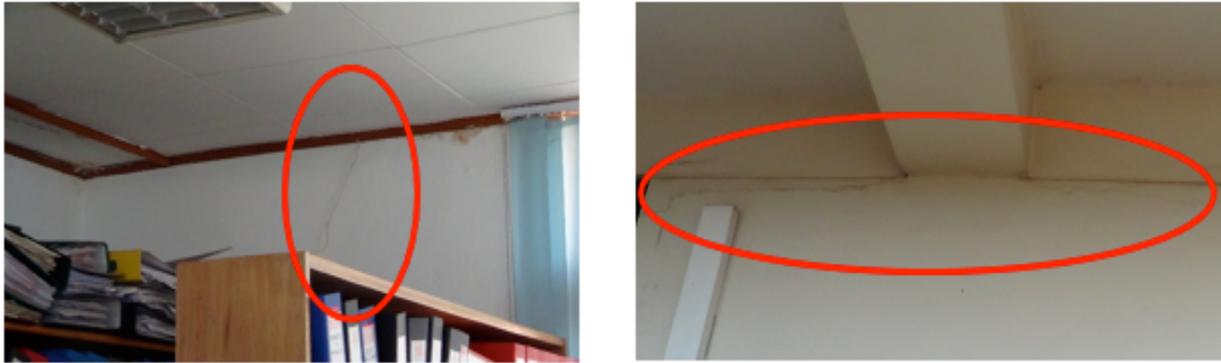
External walls may be harmful to a building if they are structurally unsound (Ahmad, 2004). Vertical or diagonal cracks in walls are common symptoms of structural instability. Cracks were identified on all the walls on every floor. These cracks were non-structural and did not pose any serious threat to the building. Different types of cracks such as vertical, horizontal, diagonal and hairlines were visually observed (Figure 7). Because these cracks were non-structural, their impacts could be neglected. However, the presence of cracks on all the walls on every floor within the building surveyed called for a major cause of concern. These cracks could have resulted from poor workmanship, weak materials joints, etc.

Figure 7: Diagonal (left) and horizontal (right) cracks on the interior walls of the building

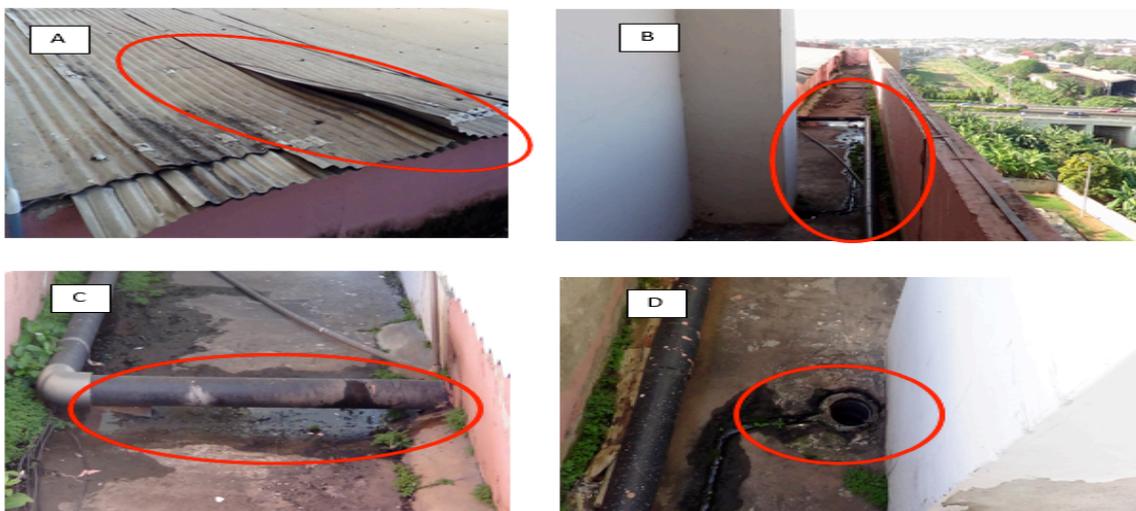
Figure 8: Slipped roofing sheets (A), leaking drainage pipes (B and C), Discontinuous discharge pipe (D)

The on-site inspection carried out on the building revealed that the roof was made up of corrugated aluminium sheets and concrete. The inspection revealed that several defects were associated with the roof. These included blocked gutters, leaking down pipes, leaking roofs, slipping roofing sheets, among others. These problems allowed water to penetrate the building and caused significant damages to the building and its interior.
