Framework in Developing Model of Interfloor Leakage in High-Rise Residential Buildings in Malaysia

Siti Rosemawar Mohd Sahi^a, Norngainy Mohd Tawil^{a*} & Kuan You Wai^b

^aDepartment of Architecture & Built Environment, Universiti Kebangsaan Malaysia, Malaysia

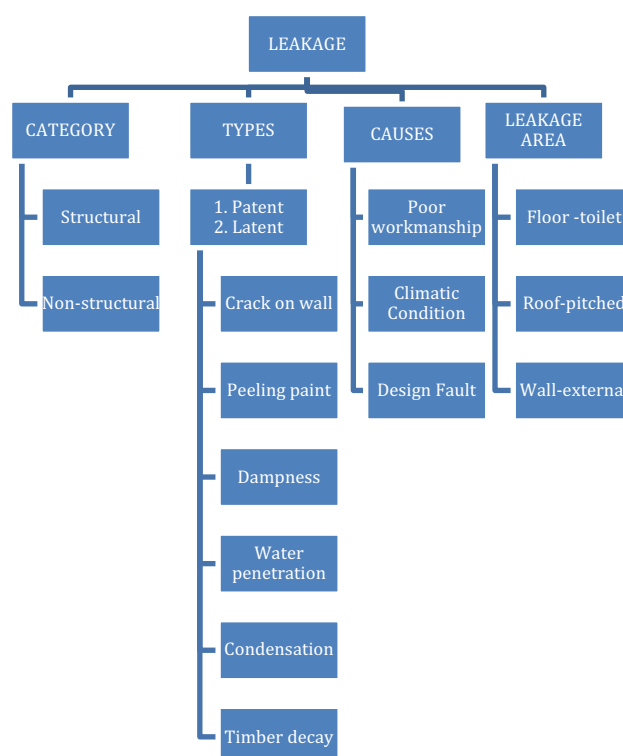
FIGURE 2. Analysis of leakage

They normally surface after DLP prior to the expiry of the typical service lifespan of the affected building components. Moreover, (Ishak et al. 2009) summarized in their research the causes of leakages according to rank as poor workmanship during construction fault, climate condition and design fault such as selection of material, detailing and supervision, as shown in Figure 2 analysis of leakage or defects.

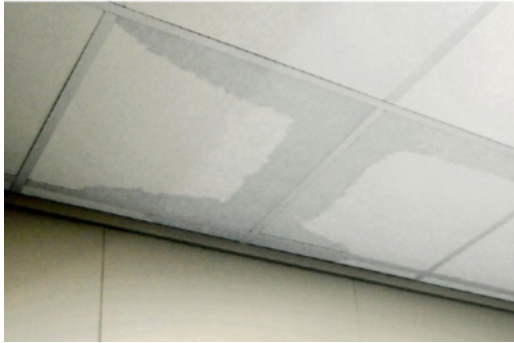
FIGURE 3. Dampness effect clearly be seen at this ceiling due to leakage from the wet area above

High humidity can cause cracks on walls and buildings, and instigate fungal growth. The SMR defines interfloor leakage as any dampness, moisture or water penetration in the ceiling, common property or limited common property along with the leakage in a strata title under Clause 55(1). Interfloor leakage's problem should be given attention because the topic is covered from Clause 55 to 64. Figure 3 show symptoms water leakage and dampness effect appearing due to leakage from the wet area above.

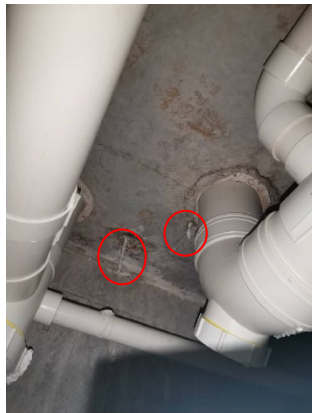
FIGURE 4. Leakage of toilet detected on the floor trap (down pipe)

When a leakage occurs, water seeps into the concrete and calthemites form (Talib et al. 2015c; Talib et al. 2015d), as shown in Figure 4. Calthemite (Figure 5) is a calcium deposit formed from concrete, chalk, mortar and other dangerous chemicals found from the building's environment. It is white and forms stalactites from the top and stalagmites from the bottom surface of a man-made structure.

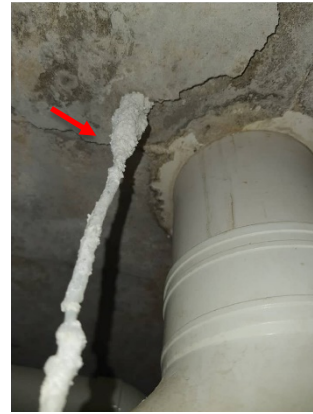
FIGURE 5. Calthemite formed from concrete

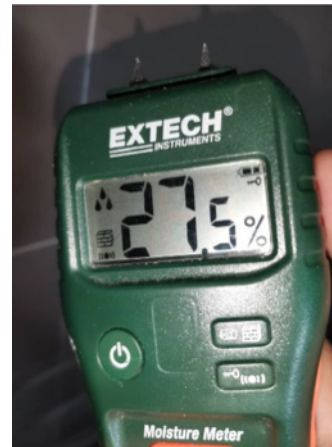
FIGURE 6. Moisture meter

The nondestructive test aims to determine the leaking path by recreating the leak at localized spots or building components without performing hacking or demolition. The tasks' inspection tools include a moisture meter (Figure 6) used to detect moisture content in materials and an infrared thermography camera (Figure 7) used to measure temperature variances of a component as heat flows through, detection of leaks, thermal bridge and structural defect.

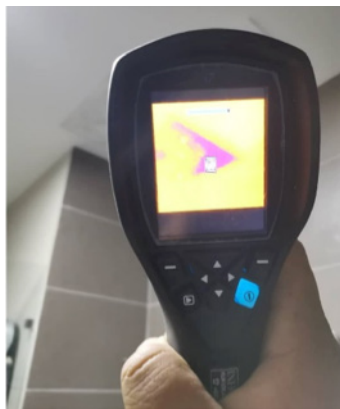
FIGURE 7. Infrared thermography camera

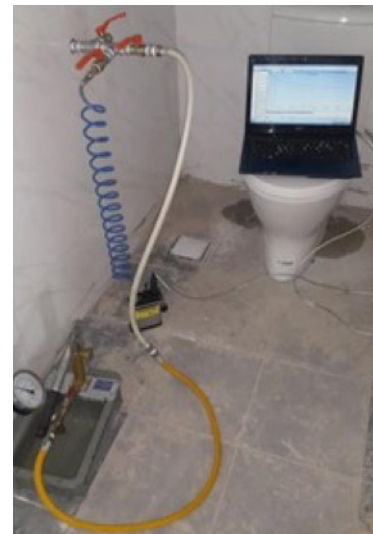
FIGURE 10. Pressure pump to test water pressure

Another nondestructive test to determine leaking is pressure gauge testing. The testing method is used to verify the water tightness of domestic water pipes. Adjusted electronic water pressure gauge chilled water a data logger used to record the variations in water pressure thoroughly and explicitly. Figure 10 shows an electronic pressure gauge testing according to the Guideline Repair Work and Testing by *Suruhajaya Perkhidmatan Air dan Tenaga*.
