## Geologic Hazard Risk Assessment of Slopeland Villages in Southern Taiwan Using Remote Sensing Techniques

SHU-RONG YANG\* & YI-LUNG YEH

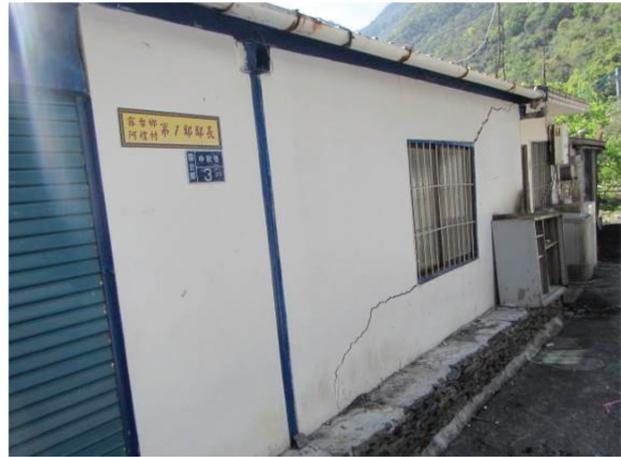
FIGURE 9. Landslide caused damage in Ali village

represented the conditions in the villages. For example, Ali, Taiwu and Jilu villages have portents of severe geologic hazard. Structures and retaining walls show signs of serious damage. This field evidence agrees with the listing of the

village in the high risk list. Field investigation photos are shown in Figures 9 through 11. It can be seen that a crack was visible in the wall (Figure 9), the retaining wall has a large crack (Figure 10) and tension cracks are visible on the ground surface (Figure 11).

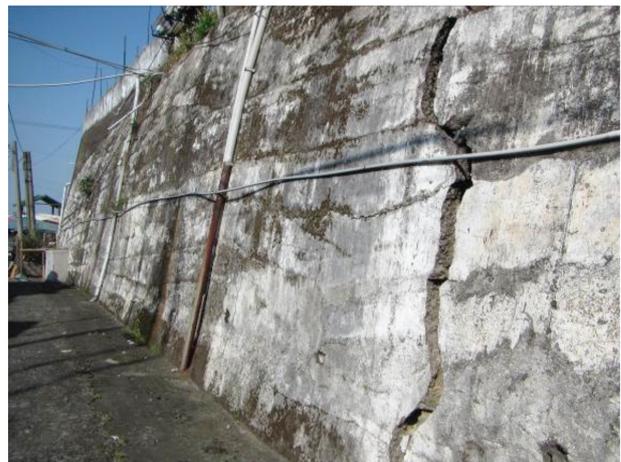
FIGURE 10. Major landslide in Taiwu village

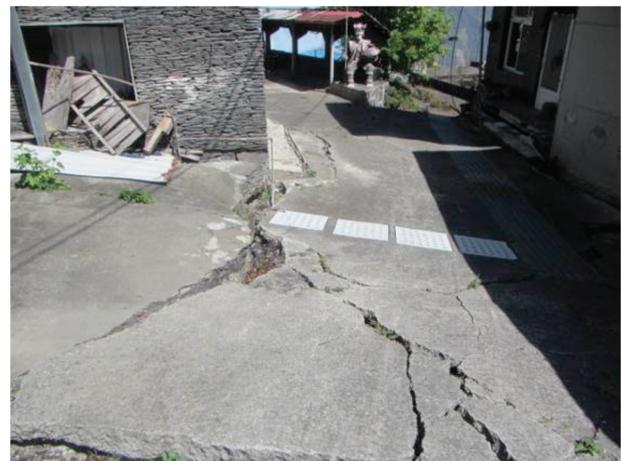
FIGURE 11. Major landslide in Jilu village
