Case Study: Inter-floor Leakage in High-Rise Residential Buildings in Malaysia (Kajian Kes: Kebocoran Antara Tingkat di Bangunan Kediaman Bertingkat Malaysia)

The subject of this case study is a freehold condominium unit located at Batu 9 Cheras, Selangor with vacant possession in July 2017. The housing scheme is accessible to Cheras-Kajang Highway, Jalan Cheras and Jalan Hulu Langat that leads to KL and Kajang. Some nearby landmarks include Central Brigade PGA Cheras and Central Selangor District Forest Office. The condominium is equipped with facilities such as a swimming pool, badminton hall, playground and 24-hour security. It is part of a three towers complex consisting 596 units with built-up areas ranging from 1,127 to 1,557 square feet.

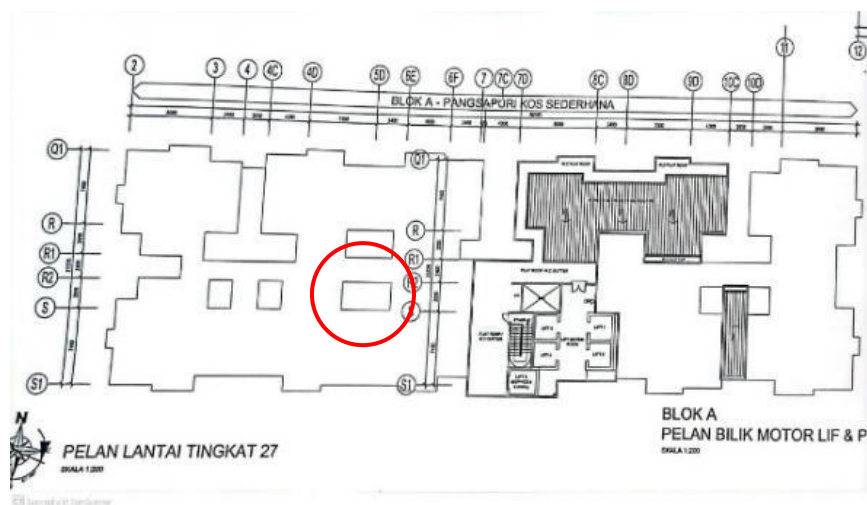
FIGURE 1. Floor plan of level 27, in the circle is the subject unit

The subject unit of this study is located on the 27th floor of the building block and has a rooftop over it as depicted in Figure 1. It consists of three bedrooms, two bathrooms, a kitchen, a balcony and a yard, with a built-up area of 1,127 square feet.

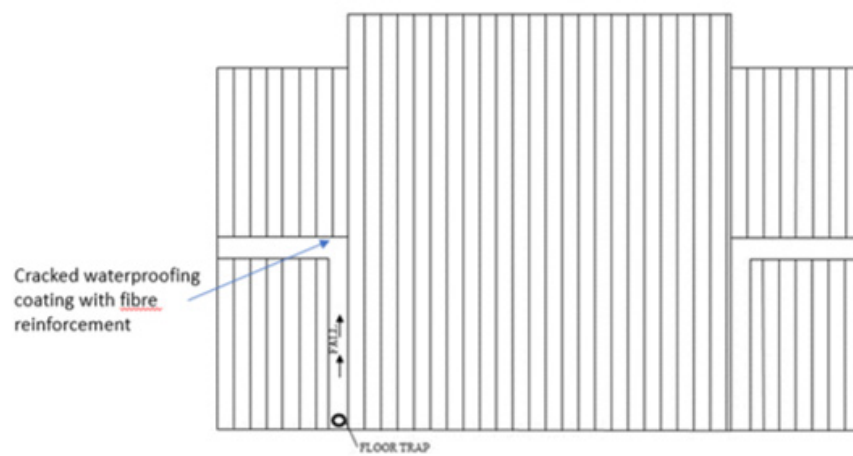
FIGURE 11. Metal roof sketch

The restoration waterproofing coating with fibre mesh reinforcement must be highly elastic to withstand all types
