## The Soft Story Challenge to Architectural Design in Earthquake-Prone Areas

### ABSTRACT

**Keywords:** *Soft story; stiffness irregularity configuration; weak story*

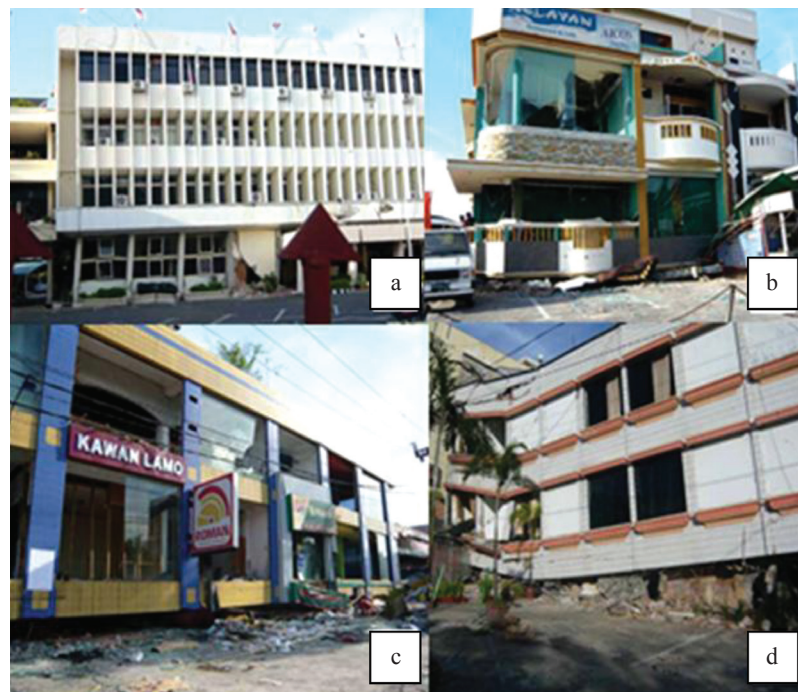
FIGURE 2. The Padang earthquake on September 30 & October 1, 2007: a). The Office of DPU Padang experienced a soft story on the 1<sup>st</sup> floor but it was still survived, b). The shophouse 3 stories experienced severe a soft story at the 1<sup>st</sup> floor. This floor collapsed, and the 2<sup>nd</sup> & 3<sup>rd</sup> floors fell on it, c). & d). The commercial building experiencing a severe soft story at the 1<sup>st</sup> floor. This floor collapsed, and the 2<sup>nd</sup> & 3<sup>rd</sup> floors fell on it (*source*: <http://www.perencanaanstruktur.com/2010/10/bentuk-keruntuhan-bangunan-saat-gempa.html>).

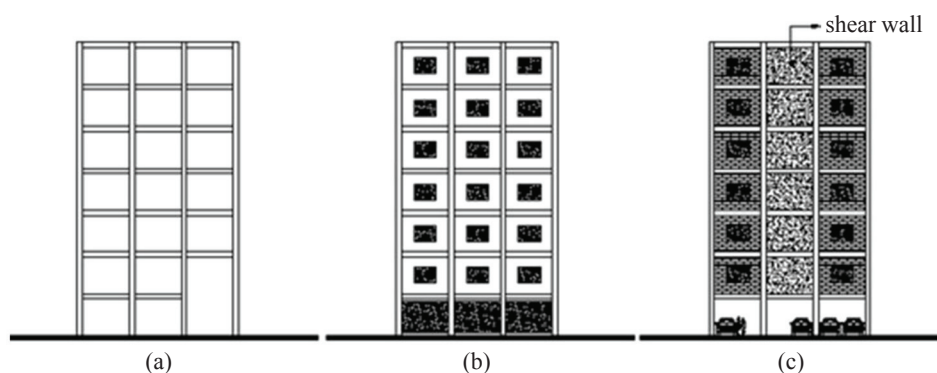
FIGURE 3. a). Some of the first stories become banking halls having height 2 stories, b). The first stories use transparent walls, and the second & third stories use massive walls, c). The first stories are open for parking and for shear wall continuing from the top story but disconnected at the first story.

Several factors that cause soft stories (Arnold 2001) are: (1). The first story's structure columns are higher than the upper stories' structure columns resulting in less stiffness and greater deformation on the first story. The first story is higher than the stories above it because it usually accommodates a large space such as a meeting room, banking hall, etc. (see Figure 3a), (2). There is a sudden change of stiffness on the second story although the height between stories is relatively the same, and this is typically mainly due to the selection of wall materials; for example, the first story, for an open impression, usually uses transparent materials such as glass that is left stiff; or if it is used as a parking lot, it is left open and the upper stories use relatively stiff wall materials such as brick walls (see Figures 3b & 3c), (3). There are shear wall discontinuities where the shear force is held by walls that are not continuous to the foundation but end only on the second story which cause sudden stiffness change (see Figure 3c).

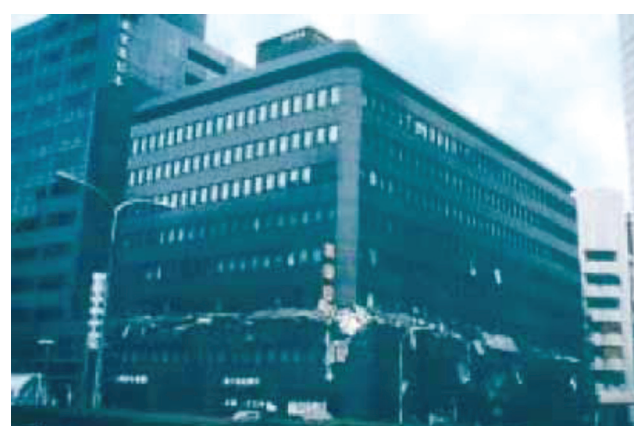
FIGURE 4. The Kobe Earthquake of 1995, the third story of the commercial building was lost and the above stories fell on it (source: Bachmann 2003).

Soft stories often occur on the first floor, but they may also occur at any floor provided the stiffness of a floor is the weakest compared to other floors (Figure 4).

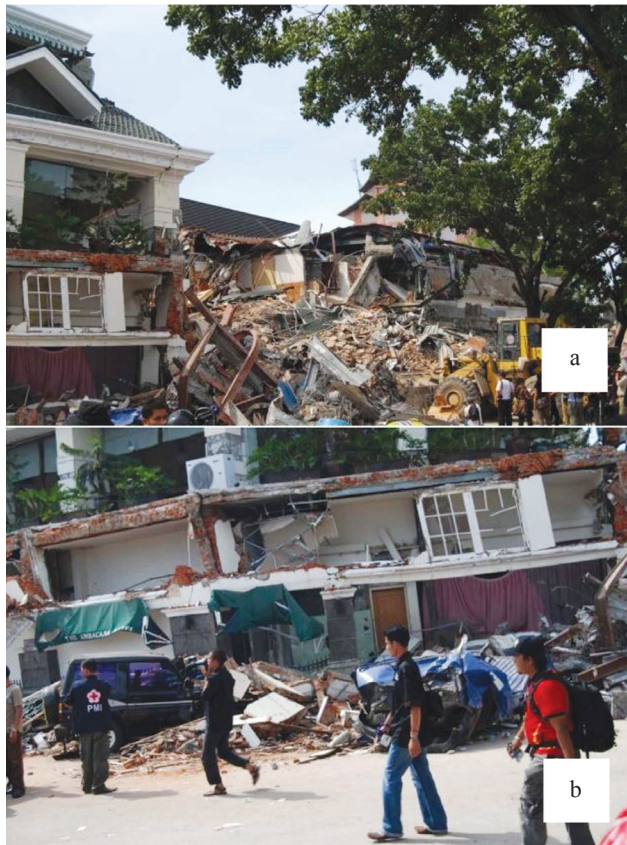
FIGURE 5. West Sumatra Earthquake in 2009, Hotel Ambacang suffered 'sandwich' collapse (source: <http://xa.yimg.com/kq/groups/17587015/808630997/name/Kerusakan+Gedung+-+GB+Padang.pdf>).

One of the most controversial cases was the collapse of Hotel Ambacang that killed 200 people. The hotel possibly suffered 'sandwich' collapse because of the soft story. In this case, the first and second floors were made of reinforced concrete material while the third floor above them was made of steel material (Figure 5). The difference of stiffness between the two materials had caused the steel structures suffered structural failure due to poor detailing, and then they fell onto the lower concrete structures.

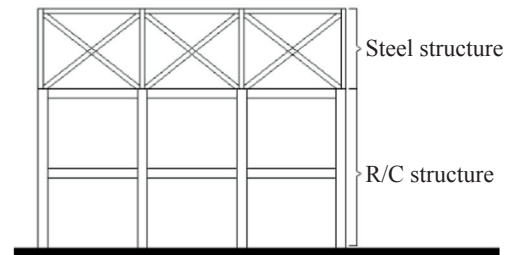
FIGURE 6. To minimize the stiffness difference between the steel material and the reinforced concrete material by adding bracing at the steel construction

The case above can be minimized by creating the steel structure having the same stiffness as the stiffness of the concrete structure such as adding bracing and improving the

detailing quality (see Figure 6). However, this method can raise the construction cost because the steel construction is more expensive than regular steel and concrete structures.

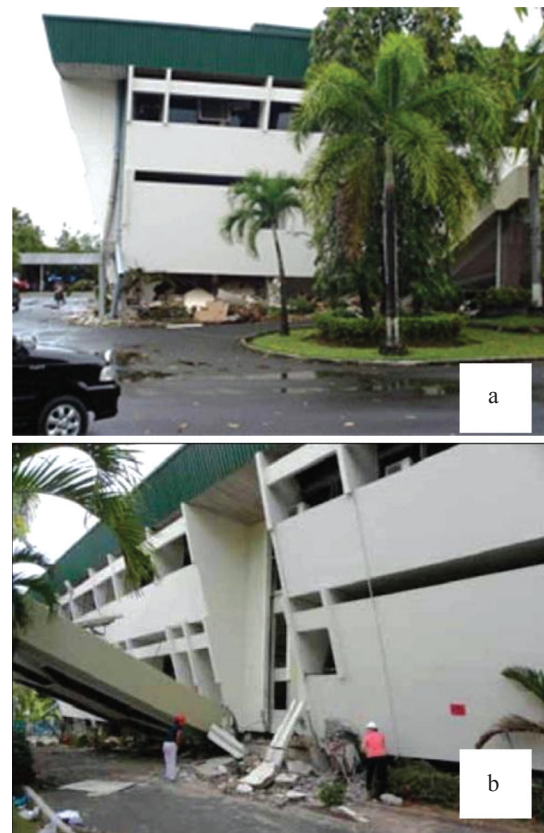
FIGURE 7. West Sumatra Earthquake in 2009. The first floor of BAPPEDA Office collapsed, but the second floor above it was relatively intact (source: Wilkinson et al. 2012).

This building consisted of three floors and made of reinforced concrete. Soft story occurred on the first floor had caused the floor to collapse while the second floor above was relatively intact (Figure 7). The shape of the building, like reversed pyramid, had caused a weak story at the first floor. In addition, the quality of concrete was also inadequate.

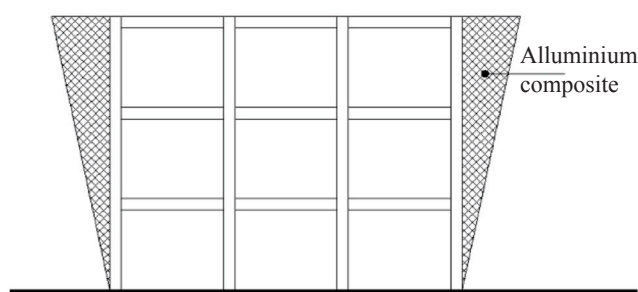
FIGURE 8. Weak story due to reversed pyramid form can be minimalized by using flexible and light materials like aluminum composite

Weak story in the aforementioned case happened when shear capacity increased because of the use of concrete planks and other concrete elements that formed a reversed pyramid and made the shear capacity and stiffness at the first floor smaller than other floors which then led to soft story. This case can actually be solved by forming wings of the reversed pyramid from flexible and light materials such as aluminum composite (ACP), so the increase of its shear capacity and stiffness is not so significant (Figure 8).

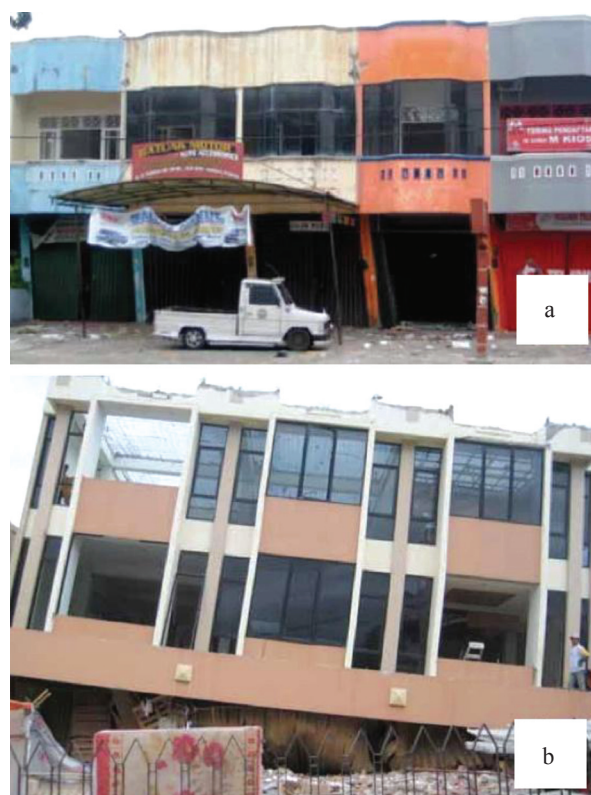
FIGURE 9. West Sumatra Earthquake in 2009, a). Ruko/shophouses undergoing residual drift, b). The first floor of the shophouses collapsed (source: Wilkinson et al. 2012).

Ruko (rumah toko)/ a shophouse is a commercial building that dominates cities in Indonesia including in earthquake-prone cities such as Banda Aceh, Bengkulu and Yogyakarta. Generally they have typical square shape where the facade has rolling gates and large windows, and shophouse units are separated by brick walls and structures made of reinforced concrete. This condition makes the shop's transversal direction more rigid than its longitudinal direction. When there is earthquake's lateral shaking, the first floor experiences a 'sway mechanism' in the direction of the longitudinal axis. Inadequate column shear capacity which is worsened by the habit of planting utility pipes in the column (Figure 10b), lack of column ductility, and poor construction have caused the residual drift (Figure 9a). If the shophouse unit is single or less, the sway mechanism on the first floor can cause 'sandwich' collapse (Figures 9b & 10a).

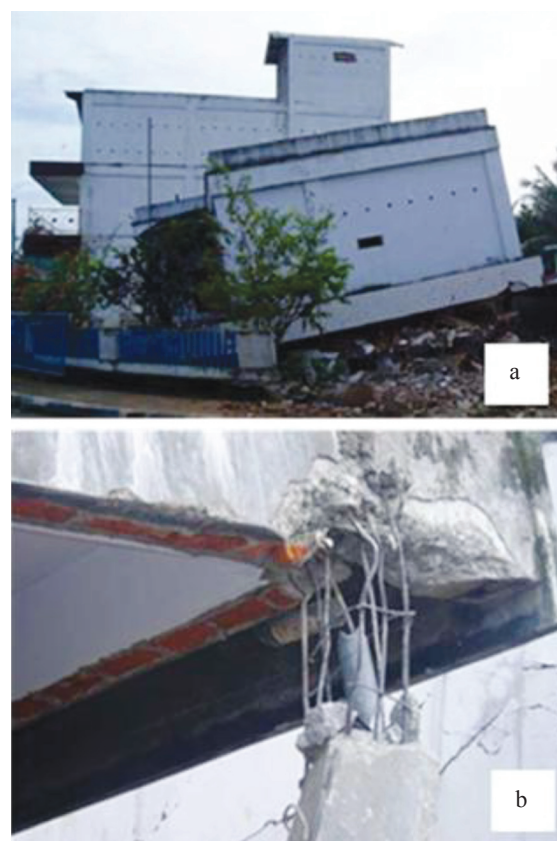
FIGURE 10. Bengkulu Earthquake in 2007, a). The collapsed shophouses, b). Planting utility pipes in the column (source: Boen 2007a).

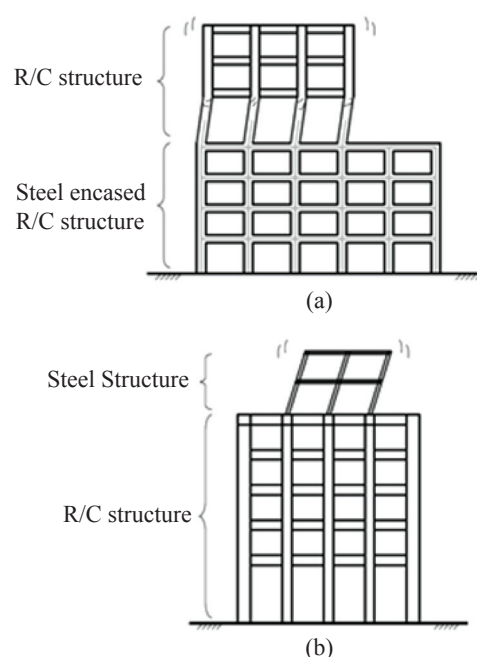
FIGURE 12. Buildings having different materials can cause soft story (source: JIA and JASO 2012)

4. Combining materials with different stiffness as the main structure of a building (Figures 12a & 12b). In figure 12b, parts of the building made of steel can still function as a service unit and not as a living unit.
5. Inadequate structural ductility and poor construction.

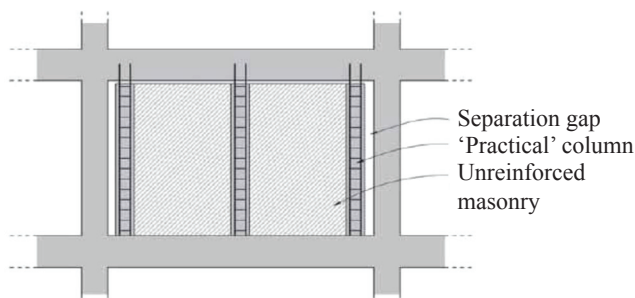
FIGURE 13. How to avoid direct contact between the brick walls and beams' and columns' main structure components (source: Charleson 2008).

1. Avoid direct contact between brick walls and columns and beams. Provide the gap between the beams and the columns with the brick walls as the walls' space to prepare for the lateral earthquake. Fill the column's gap with brittle or elastic materials to avoid the damage during the earthquake (Charleson 2008) (Figure 13).

In structural calculation, brick walls is usually assumed as non-structural, but in reality, the brick walls having density  $> 1\%$  can influence the building's stiffness. Therefore, when a strong earthquake occurs, plus the existence of brick walls stiffness contribution, the building behavior towards the earthquake is often not like what the planners expect. Avoiding the direct contact between brickwalls and the structural elements is one of the ways to reduce brick walls stiffness contribution towards the building structure.

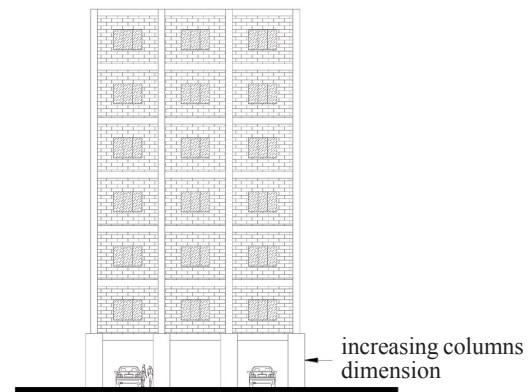
FIGURE 14. The increase of the first floor's column dimension 2.5 times can influence proportion of the building facade and the first floor width.

The increase of the first floor's column dimension 2.5 times can influence proportion of the building facade and the first floor width (Figure 14). To reduce its effect, combine the increasing column dimension and reinforcement area.

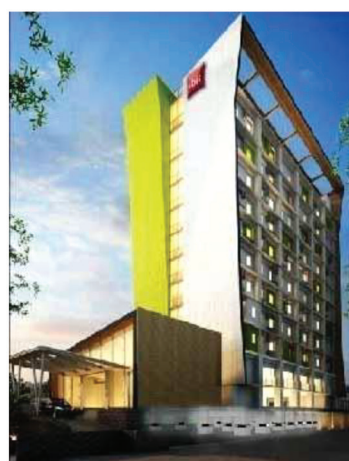
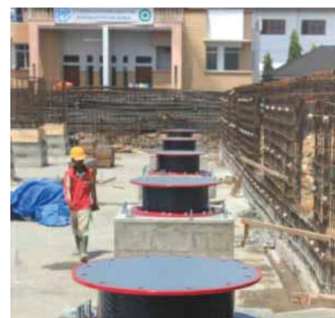
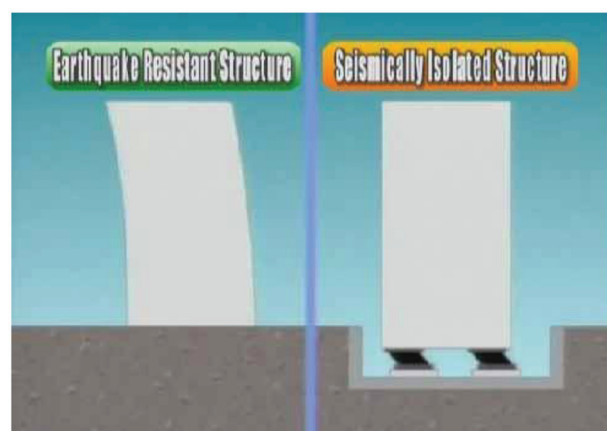
FIGURE 17. (a). Hotel Ibis Padang, (b). Installation of base isolator, (c). The working mechanism of the base isolator (*source*: Suardi 2013).

5. The use of seismic insulation comprehensively improves the building's performance that has soft stories, and it also effectively reduces the seismic demand (eg, interstory drift) at the soft story level that can cause catastrophic collapse (Pinarbasi, Konstantinidis, and Kelly 2007) (Figure 17).

The general principle of an earthquake-resistant building is that the shear force capacity of the building structure must be made bigger than the earthquake force while the principle of the isolator use, which is the reverse of the previous principle, is that the earthquake force is made smaller than the shear capacity of the building structure. In this kind of circumstances, the base isolator functions as a device to reduce the earthquake force before entering the building structure. Therefore, among the buildings that have soft stories, when strong earthquakes occur, the ones using base isolators can reduce deformation better than the ones not using base isolators (Figure 17c).
