## Seismic Resistance Evaluation of Reinforced Concrete (RC) Exterior Beam-Column Joints with and without GFRP under Quasi-static Lateral Cyclic Loading by Adopting Experimental Analysis

S.A. Osman\*, M.Y.M Yatim, Asma Nabila binti Abd. Kader & Mohd Razmi Mohd Amit

*Department of Civil Engineering, Faculty of Engineering & Built Environment, Universiti Kebangsaan Malaysia, Malaysia*

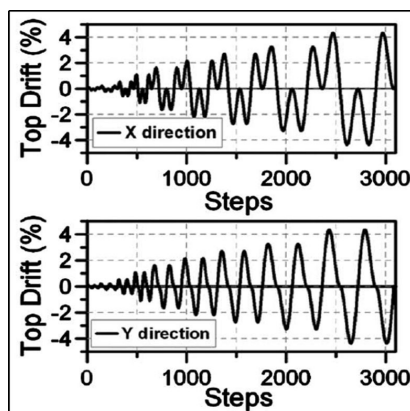
The loading scheme used in this experiment is shown in Figure 5. Two cycles were performed for each drift level. The sample was loaded to drift. The damages to the specimen were visually observed and recorded.

(a) Loading pattern

(b) Displacement components

FIGURE 5. Loading regimen applied in this experiment (Akguzel and Pampanin, 2010)

According to Akguzel and Pampanin (2010), the 2D loading protocol was extended to the 3D dimensions by choosing a cloverleaf-shaped loading path in the 3D configuration tests. At each chosen drift level, a complete cycle of the cloverleaf shape was circumscribed. During each complete cloverleaf cycle, the 3D specimens were subjected to a total of two deflections in the positive and negative directions in the x-axis and y-axis. However, in this experiment, only one actuator is used, which is located at the edge of the outer side of the column, which means it is in

the middle of the x-axis and the y-axis direction. Therefore, in this experiment, it is assumed that there would be a combination of the loading pattern and the displacement components of the x-axis and y-axis.

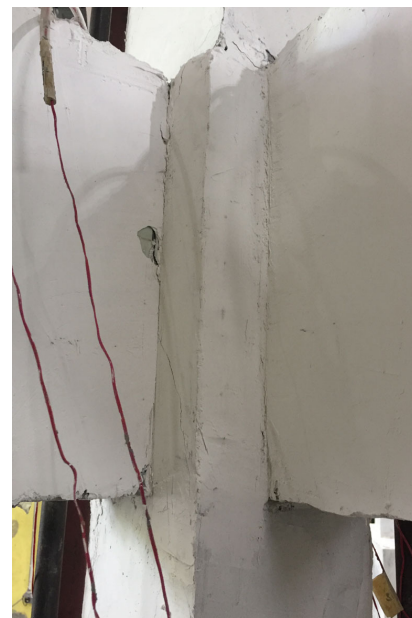
During the experimental work on BCJ with GFRP specimen, there is an error occurred due to a malfunction on the machine (the machine keeps on running and fail to stop during the process to adjust the set-up of actuator at the very beginning of the experiment) which causes cracks on the specimen. Within the inelastic region, major cracks occurred at  $\pm 0.10\%$  drift, leading to a fracture of a thin layer of gypsum covering the GFRP as shown in Figure 6.

FIGURE 6. Exposure of GFRP sheet and cracks occurred on the specimen due to machine malfunction before the experiment of BCJ with GFRP

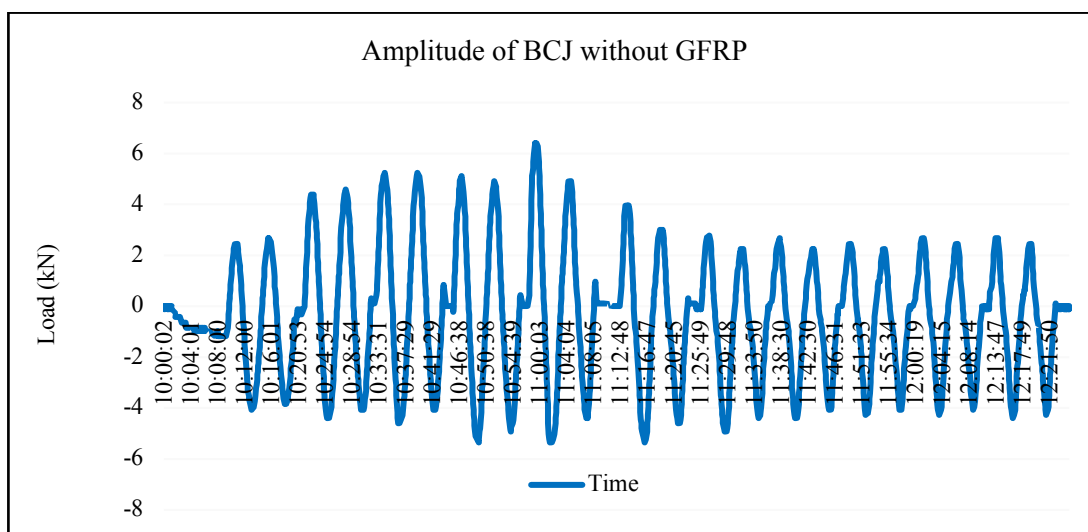
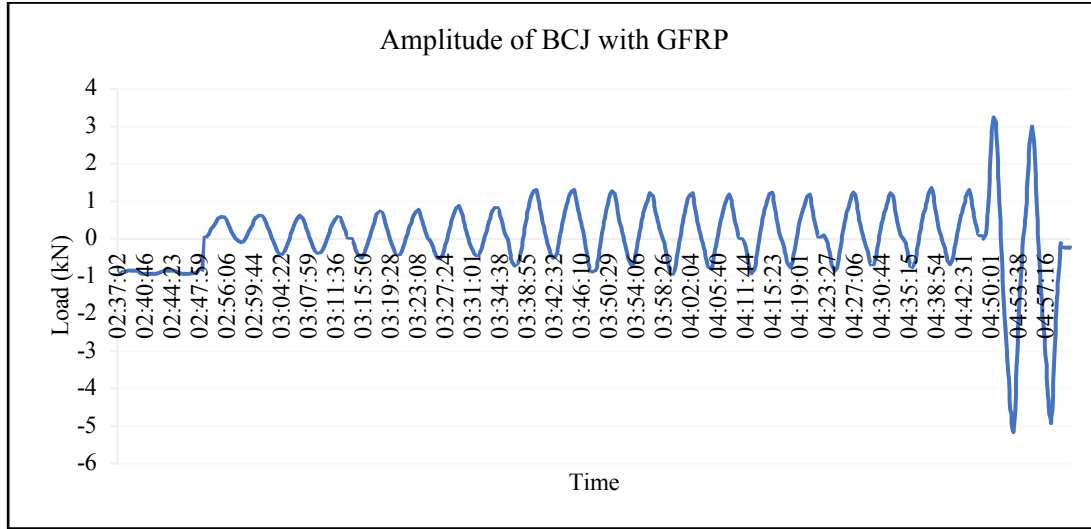
reinforcement were measured. The maximum amplitude value and frequency component have been regarded as the most important indicators of seismic engineering among the various indicators of seismic motion. (Shoji et al. 2004). The graphs of amplitudes for beam-column joints with and without GFRP are shown in Figures 10(a) and 10(b). The load value for the BCJ without GFRP for the first cycle in the positive (compressive) direction is highest at 0.75% drift with a value of 6.4kN, while the lowest value for the negative (tensile) direction is -5.34kN. For the load value of the BCJ with GFRP, the first cycle in the positive

(compressive) direction is highest at  $\pm 2.00\%$  drift with a value of 3.12kN, while the lowest value for the negative (tensile) direction is -5.16kN. The amount of energy carried by a wave is proportional to its amplitude. A significant amount of energy is carried by high-amplitude waves and a small amount of energy is carried by low-amplitude waves. From the amplitudes of the two samples, it can be seen that the amplitude of BCJ with GFRP is lower than BCJ without GFRP. This indicates that the presence of GFRP lowers the loading's intensity.

(a) Amplitude of beam-column connection without GFRP

(b) Amplitude of beam-column connection with GFRP

FIGURE 10. Graph of Amplitudes of the beam-column connections with and without GFRP

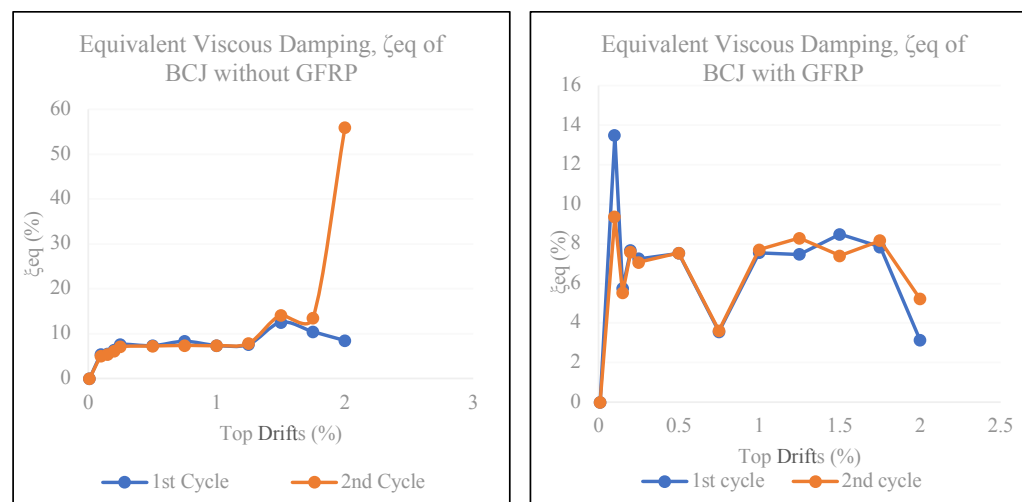
GFRP obtained using Equation 1 for the first and second cycles. From the values obtained in Table 1, the graphs of equivalent viscous damping,  $\zeta_{eq}$  versus the drifts of the beam-column joints with and without GFRP are plotted as shown in Figure 11.

FIGURE 11. The graphs of Equivalent viscous damping,  $\zeta_{eq}$  versus the drifts of the beam-column joints with and without GFRP

The second cycle of beam-column joint without GFRP, however, has a larger value of equivalent viscous damping than the first cycle at a 1.25 % drift. This indicates that if the drift is 1.25 %, the specimen will absorb more energy in the second cycle and suffer more damage than in the first. The first cycle usually refers to the earthquake’s first shock, whereas the second cycle refers to the earthquake’s aftershocks. The same can be said for the GFRP beam-column joint, which experienced a similar condition at 0.50% drift.

4. Because the first cycle requires more energy to withstand the strength of the beam-column joint than the second cycle, the equivalent viscous damping,  $\zeta_{eq}$  of both specimens is higher for the first cycle than for the second cycle. However, with a drift of  $\pm 1.25\%$ , the second cycle of the beam-column joint without GFRP has a higher value of equivalent viscous damping than the first cycle. This means that at  $\pm 1.25\%$  drift, during the second cycle, the specimen will absorb more energy and be more damaged than during the first cycle. The first cycle usually refers to the earthquake's first shock, whereas the second cycle refers to the earthquake's aftershocks. The same applies to the beam-column joint with GFRP, which experienced the same condition with a drift of  $\pm 0.50\%$ .
