Some Problems on the Slope Handling in the Highway Construction in China (Beberapa Masalah dalam Pengendalian Cerun dalam Pembinaan Lebuh Raya di China)

HUANG DONG, WEI ZUOAN, CHEN YULONG* & IRFAN MUHAMMAD

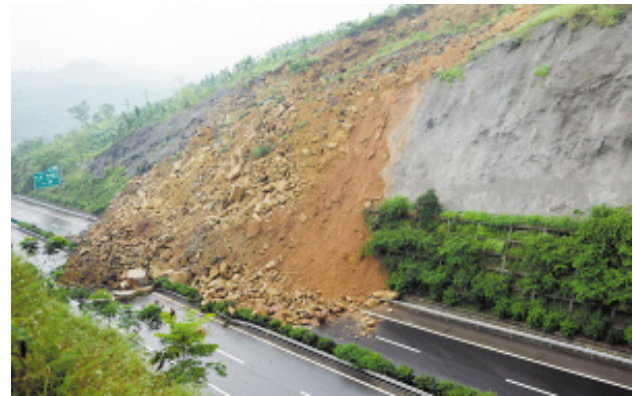
FIGURE 1. A landslide at Yu-Wan highway after completion

therefore some slope parameters, such as the slope angle, are usually determined through experiences or directly based on the technical standards. It may be permitted to do so in the past because the technologies were poor and backward at that time (Kamsani et al. 2017). But now the relevant theories have already been quite mature and the computation technology has been also advanced. To do something just by experiences is out of date and cannot meet the requirement of project, even causing very dangerous results, as shown in Figure 1.

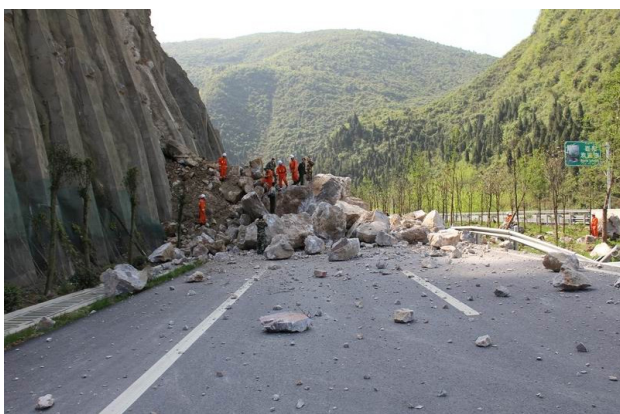
FIGURE 2. A collapse occurred at a handled slope

In addition, the lifetime of reinforced projects is not clear. It is well known that the lifetime of brick-concrete house is 50 years according to national regulations. However, there is no standard related to the slope handling, which results in that landslides of some handled slopes still reoccur, as shown as in Figure 2.

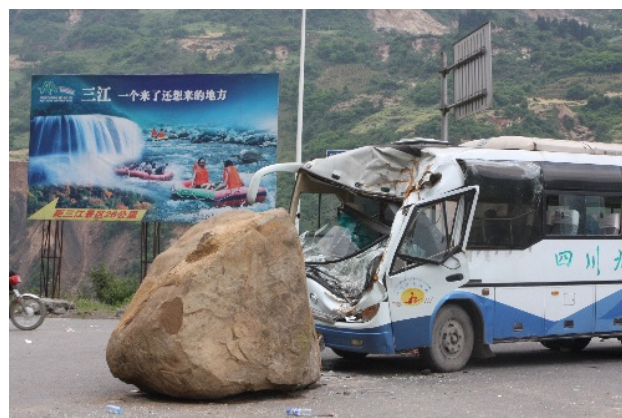
FIGURE 3. A rock fallen from a slope hits a bus

Additionally, fallen rocks are usually failed to be considered in highway construction. Therefore, there are many disasters occurred during the highway operation, as shown in (FIGURE 3).

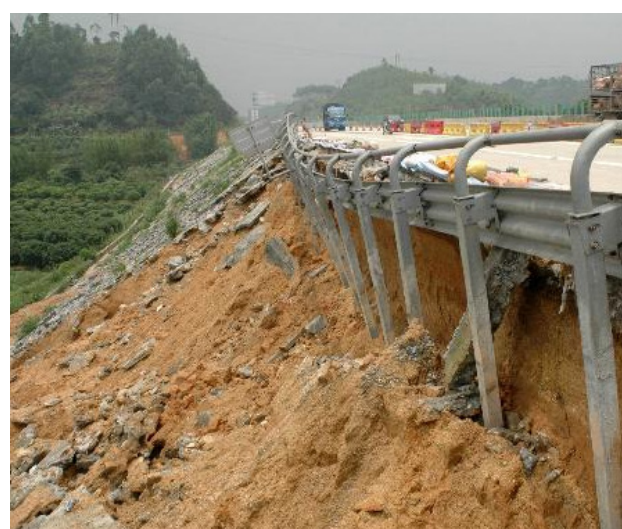
FIGURE 4. A collapse of backfilled slope

The stability of backfilled slope is often ignored. The engineers usually pay more attention to the stability of cut slope, but they always ignore the stability of backfilled slope. These because many backfilled slopes collapse in varying scale in rainy season, as shown in (FIGURE 4), which badly influences the normal traffic.
