Tricycles for Nigerian Public Transport Unit: Assessment of Ergonomics Design Considerations

ABSTRACT

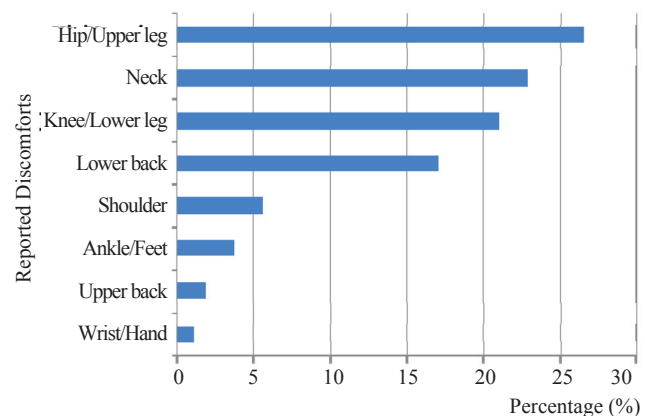
Figure 1 shows passengers' responses to level of discomforts with the use of Tricycle. About 59% of the total participants reported discomforts any time they are conveyed in the sampled Tricycle. The highest percentage (26.6%) of the total respondents, among passengers who reported discomforts, indicated the pains at hips/upper legs. This is followed closely by 22.9% and 21.0% who indicated it at neck and knees/lower legs respectively. Other discomforts reported comprised of strains at lower back (17.1%), shoulders (5.6%), ankles/feet (3.7%), upper back (1.9%) and wrists/hands (1.1%).

FIGURE 1. Passengers' responses to level of discomfort with the use of Tricycle

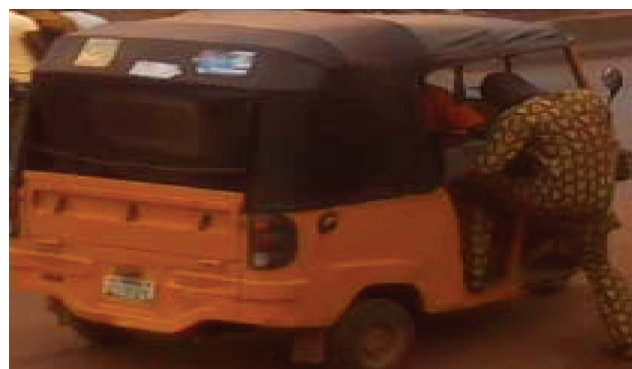
FIGURE 2. Showing a passenger in an extreme bending posture while entering the Tricycle

The conditions shown in Figures 2 and 3 are due to insufficient entrance space available for user's height and narrow space available at the entry. Similar to these observations are common among tricycle users which is suggested as one of the reasons for passengers' complaints of discomforts.

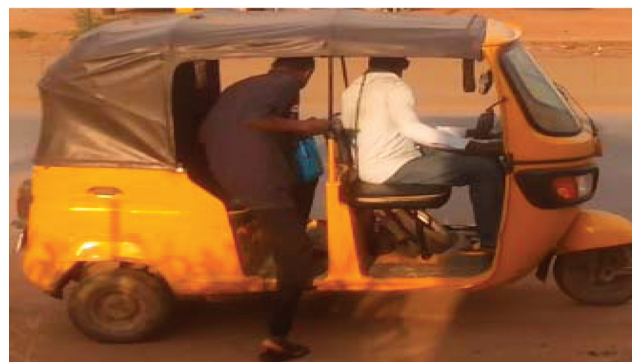
FIGURE 3. Showing awkward postures of user entering the Tricycle using his side

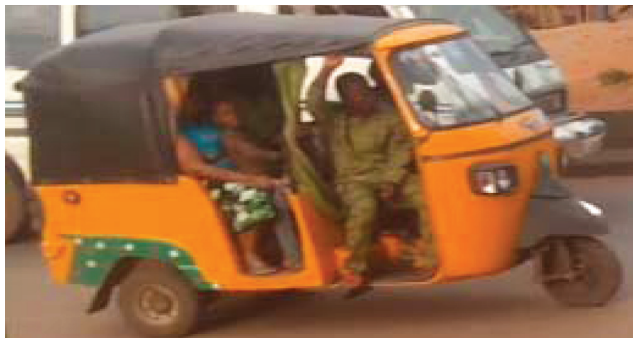
FIGURE 3. Showing the awkward sitting postures of a passenger holding on to roof horizontal supporting frames to keep himself in position and avoid falling out

Figures 3 and 4 shows a condition where the space available for driver is shared by passengers. Those passengers sit uncomfortably with unnatural postures. The width of the driver's seat (30.5cm) is actually designed for one person. However to increase daily income, two people occupy the space leading to both the passenger and driver not being comfortable. It was also observed that there is no provision for hand support and so the passengers locate their hands at any available part of the tricycle for stability while their legs are almost outside. This exposes the passengers to road dangers. External contact stress could also occur because some parts of passengers' body are rubbed against component of the

Tricycle, such as frame (as noted in Figure 4) and edge of the body (as observed in Figure 3). Nerves may be irritated resulting to pains in those regions of their body.

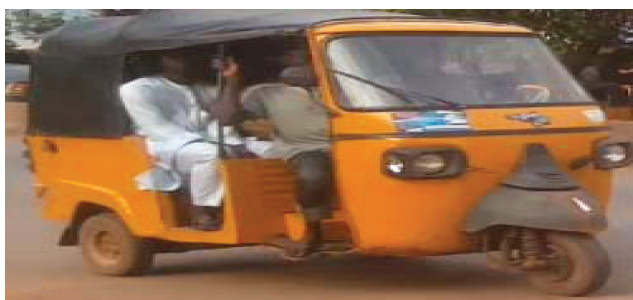
FIGURE 4. Showing awkward sitting postures of a passenger holding on to vertical supporting frames to maintain stability and resist tendency to fall out

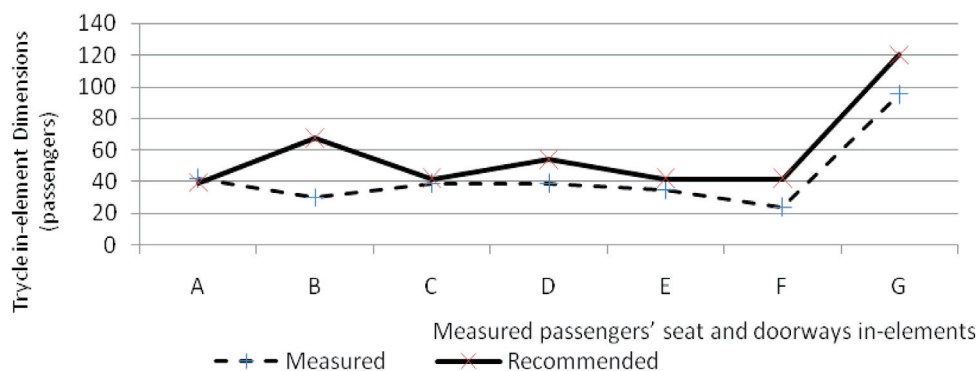
Table 3 presents the dimensions of measured Tricycle seats, access and exit doors and the corresponding standard recommended for urban transport unit. It also displays the corresponding anthropometric data. This information is graphically presented in Figure 5.

FIGURE 5. Comparing passengers' seat and doorways of the studied tricycle with the standard recommended for urban transport unit
